# NAVAL POSTGRADUATE SCHOOL

## THESIS

USE OF IMPLANT TESTING TO EVALUATE  
THE SUSCEPTIBILITY OF HY-130 STEEL  
WELDMENTS TO HYDROGEN EMBRITTLEMENT

December 1981

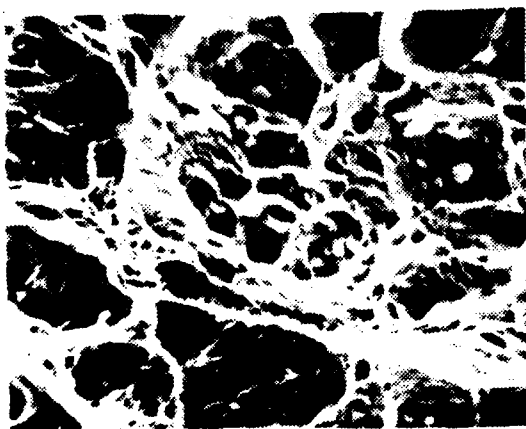
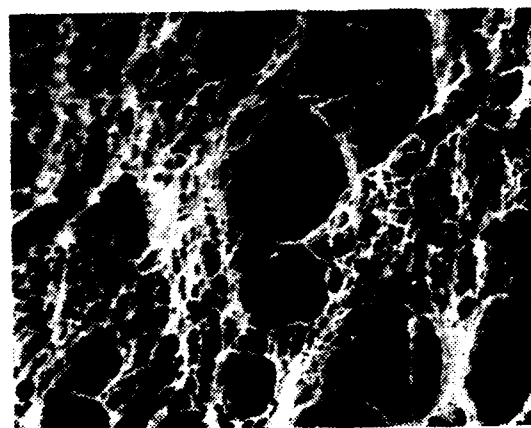
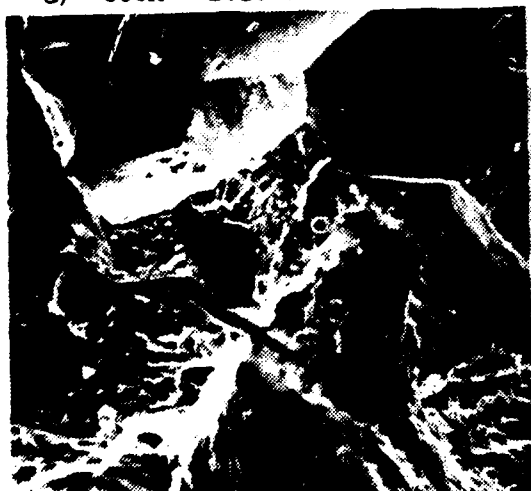
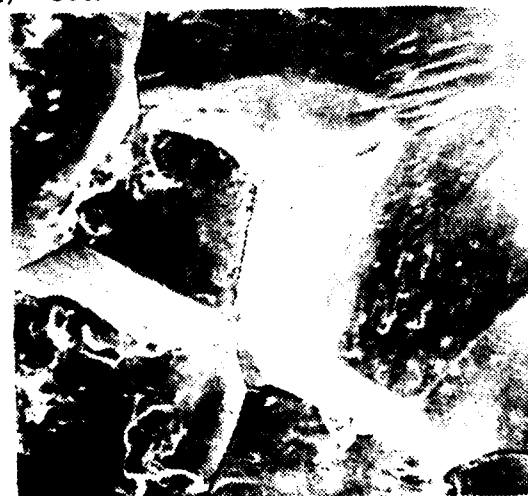
a) 50X, 1.1 ppm H<sub>2</sub> (60% Ductile)

b) 50X, 14.4 ppm H<sub>2</sub> (25% Ductile)

c) 500X - Dimpled Fracture

d) 500X - Dimpled Fracture

e) 500X - I.G. Fracture

f) 500X - I.G. Fracture

Figure 28. Plate 6, Longitudinal Direction, Normal (Left) and Enhanced Hydrogen (Right) Welding Conditions

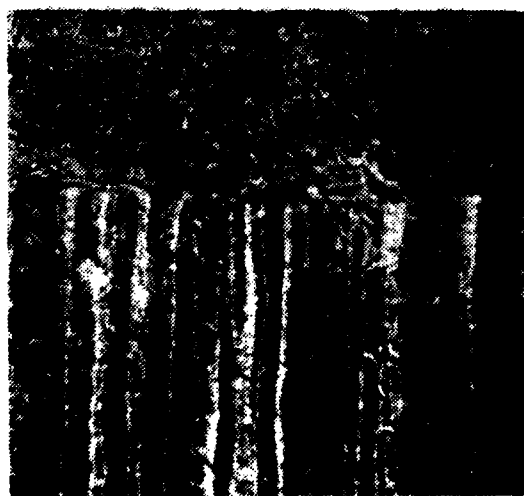
- a) 64X - Crack Initiation Site at the Root of the Helical Notch in an Unfractured Implant Specimen

- b) 250X - Crack Initiation Site at the Root of the Helical Notch, 2% Nital Etch - 30 Seconds, Crack Appears to be Intergranular in Nature.

- c) 64X - Weld Penetration and Banding Visible in the Rolled HY-130 Plate, 2% Nital Etch - 30 Seconds.

Figure 37. Crack Initiation Site and Alloy Banding of Plate 2 (Wrought Plate)

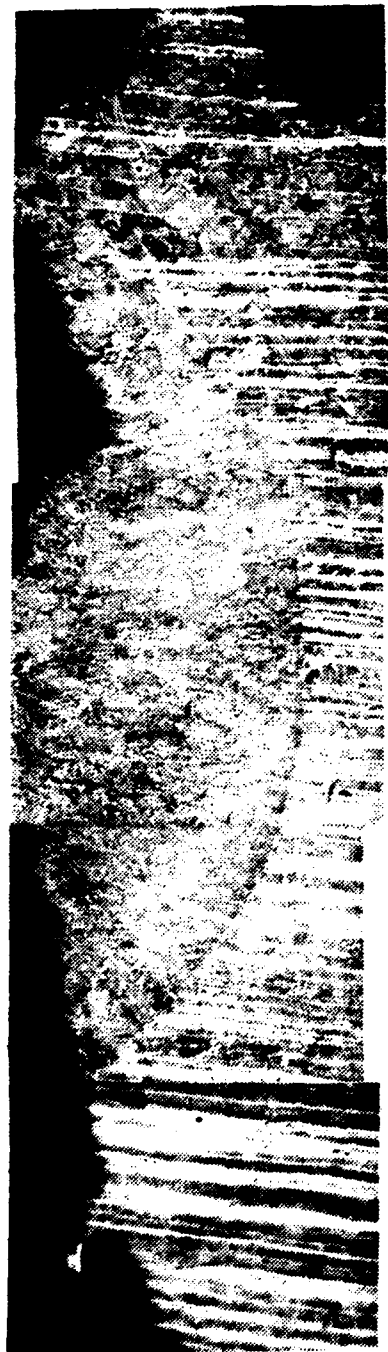
a) 64X - View of Fracture Surface, Enhanced Hydrogen Welding Conditions, 1% Nital Etch. Fracture Occurred Throughout the Weld Metal (Reduced 40%)

b) 64X - View of Fracture Surface, Normal Welding Conditions, 1% Nital Etch. Fracture Occurred Entirely in Base Metal Heat-Affected Zone (Reduced 40%)

Figure 38. Microstructure of Fractured Implant Specimens  
from Plate 2

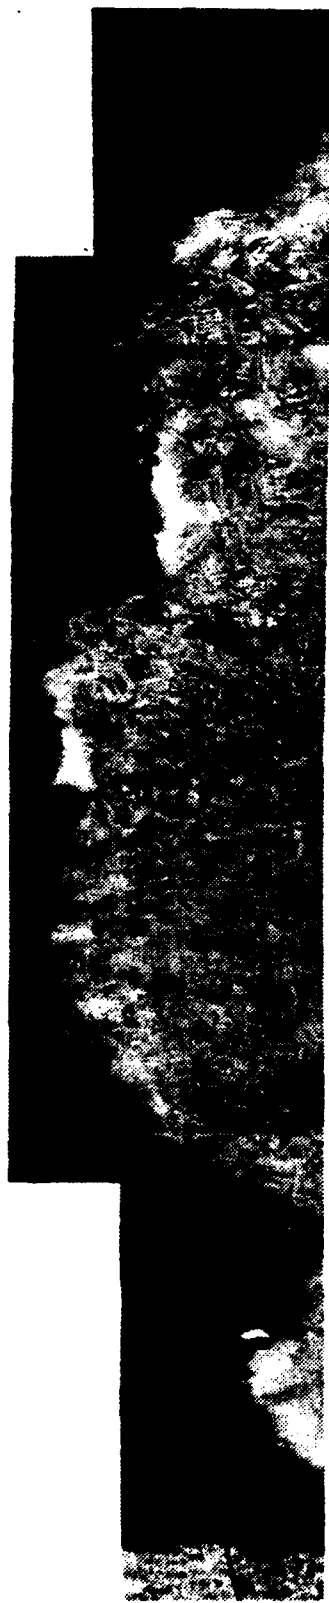
a) 64X - View of Fracture Surface, Enhanced Hydrogen Welding Conditions, 1% Nital Etch. Fracture Occurred Through Base Metal Heat-Affected Zone (Reduced 40%)

b) 64X - View of Fracture Surface, Normal Welding Conditions, 1% Nital Etch. Fracture Occurred Primarily Through the Base Metal Heat-Affected Zone (Reduced 40%)

Figure 40. Microstructure of Fractured Implant Specimens  
from Plate 6
